Dam ID: HI00064

FIELD 2 KEALIA
AKA KANEHU 2

STATE OF HAWAII - DLNR
DAM SAFETY INSPECTION SHEET

Date: 4/8/2006

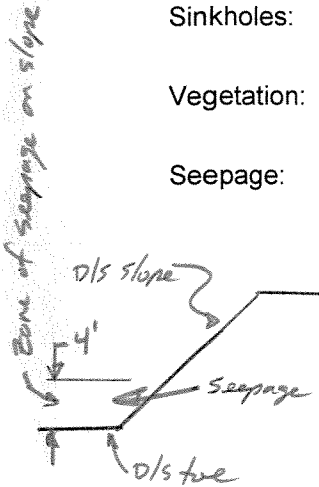
Seepage: Seep Spot Number 1

☒ Flowing, Description: 20 to 40 gpm from seepage emanating out of

Description: Seepage exiting from the lower 4' of slope to the left of the outlet works

- ☒ h. Seepage/Ponding water was observed. Monitor and conduct further investigation to locate the source of water and extent of any possible hazardous or developing condition.

- ☐ j. The slope was very steep, around a 1 to 1 slope, further study is required to verify slope stability.
- ☒ k. Heavy seepage was exiting the lower slope of the dam. The reservoir pool should be lowered immediately.
